Case study

## **AIRPLANE CABIN INTERIOR LEAKAGE DETECTION AND SOURCE LOCALIZATION**

Using Microflow Scan&Paint 3D & Voyager

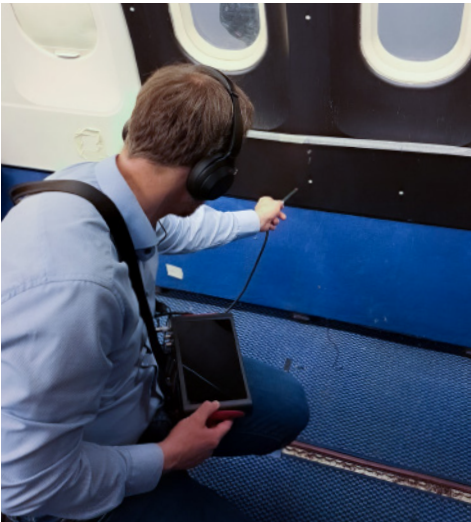
### The Voyager

This case study utilized two measuring solutions to tackle acoustic challenges. The Voyager, a portable multi-channel acoustic analyzer, captured data through listening tests conducted by scanning with a PU probe near the cabin panels. The evaluation encompassed sound pressure and particle velocity signals. Real-time filtering tools were employed to concentrate the output on specific frequency bands of interest. Leveraging the distinctive capabilities of particle velocity proved invaluable in the field, particularly for detecting acoustic leakages.

After conducting a pre-scan with the Voyager, crucial areas of interest were identified and located. This facilitated the subsequent action of Scan & Paint 3D. Once the 3D measurements were completed, Lufthansa and Microflown obtained a visual reference of the sound field propagation and sound intensity distribution around the cabin. This enabled them to assess the various emitting areas across multiple critical frequency ranges.

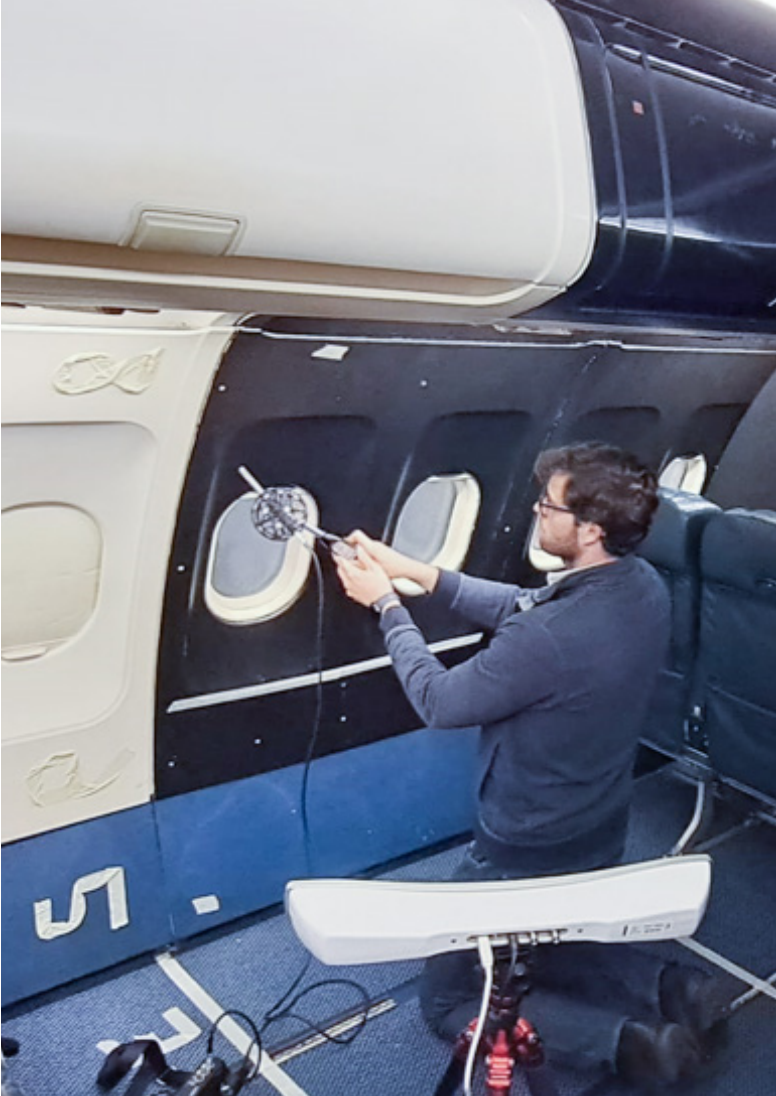
### Scan&Paint 3D

The Scan & Paint 3D system incorporates a 3D sound intensity probe. This probe consists of one microphone and three orthogonal particle velocity sensors, enabling comprehensive capture of acoustic information. The probe is fixed to a sphere equipped with IR reflectors, tracked by a stereo camera for precise positioning.

In the case study, an entire cabin section was efficiently scanned in just around 30 minutes using this 3D sound visualization system. To achieve this, multiple measurements were taken of each sub-section individually, with an average measurement duration of approximately 4 minutes. This approach ensured accurate and detailed analysis of the sound field in the cabin, providing valuable insights for effective noise control and troubleshooting efforts.

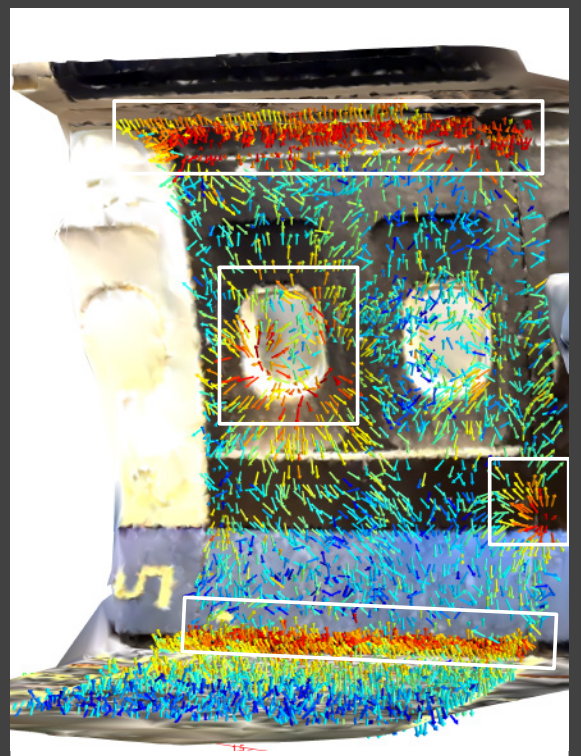
## 4 kHz octave band

The upper and lower sections show similar behavior to previous bands. The left window, close to the outside speaker, is a significant radiation area for this frequency band too. Radiation/leakage is concentrated around the bottom sides of the window. Particularly, there is a specific area at the far right where the panel bottom walls intersect, showing strong radiation.
